APPENDIX G

PROJECT NEED INFORMATION

Problem Assessment

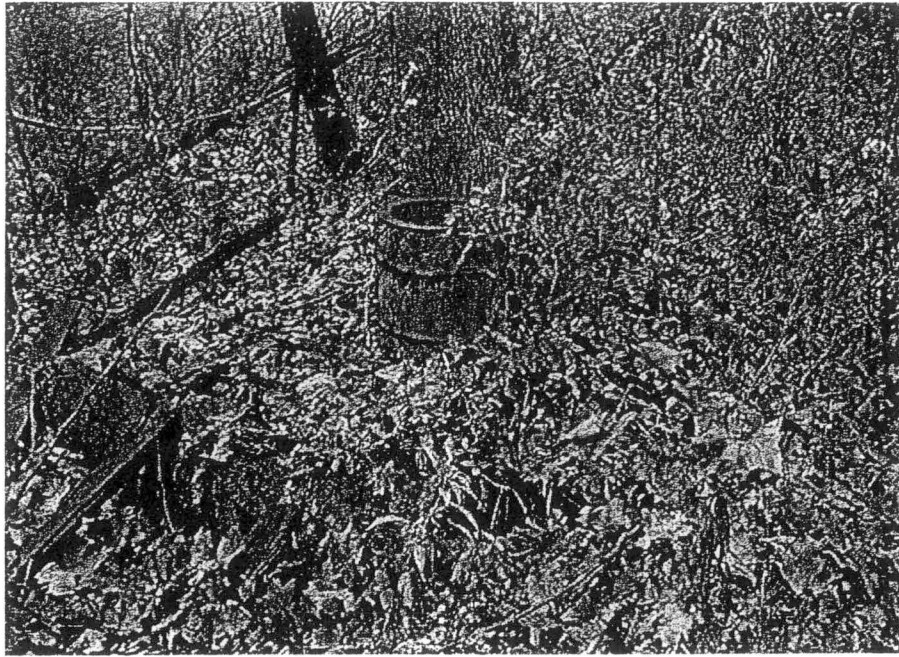
Figure A3: A view of what is believed to be the business's septic tank. The building is located uphill, to the right of the photo.

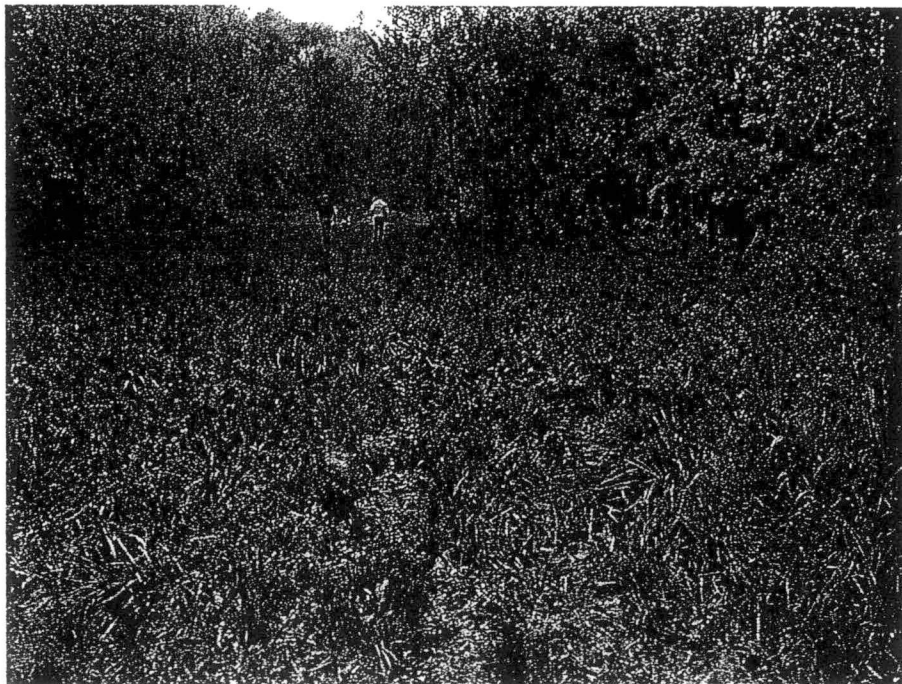
Figure A6: A view of the trailer court's leach field, located west of the septic tank shown in Figure A4. Again, dark wastewater and abnormal plant growth are present.

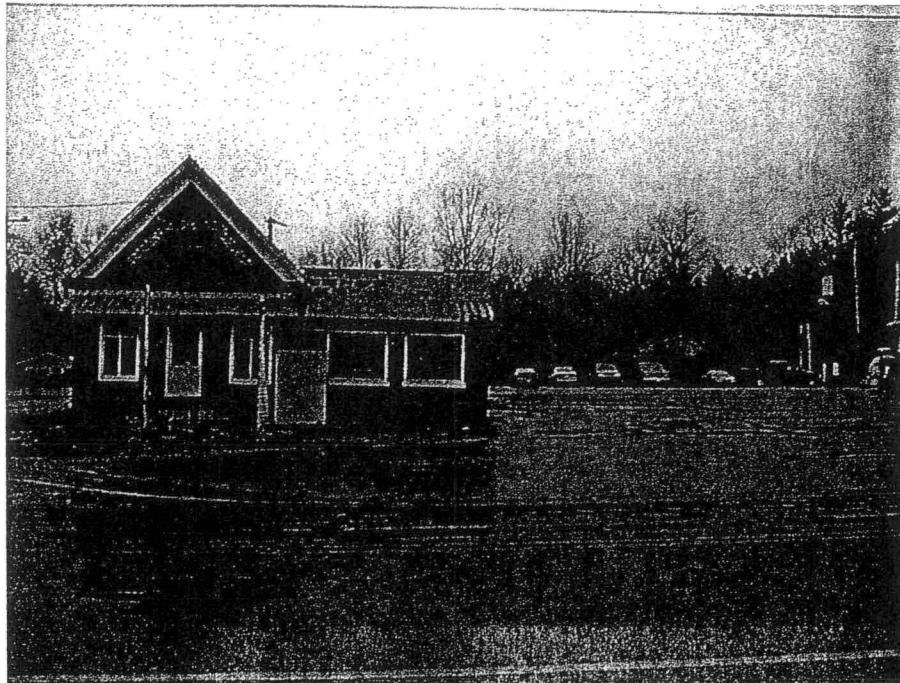
Figure A8: A view of another small business at the intersection, located just south of the supermarket. The building doesn't have working restrooms because of the failing septic systems at the location.
